Rotorcraft Downwash Flow Field Study to Understand the Aerodynamics of Helicopter Brownout

Presented at the American Helicopter Society Southwest Region Technical Specialists' Meeting, "Technologies for the Next Generation of Vertical Lift Aircraft," Dallas-Fort Worth, TX, October 15-17, 2008.

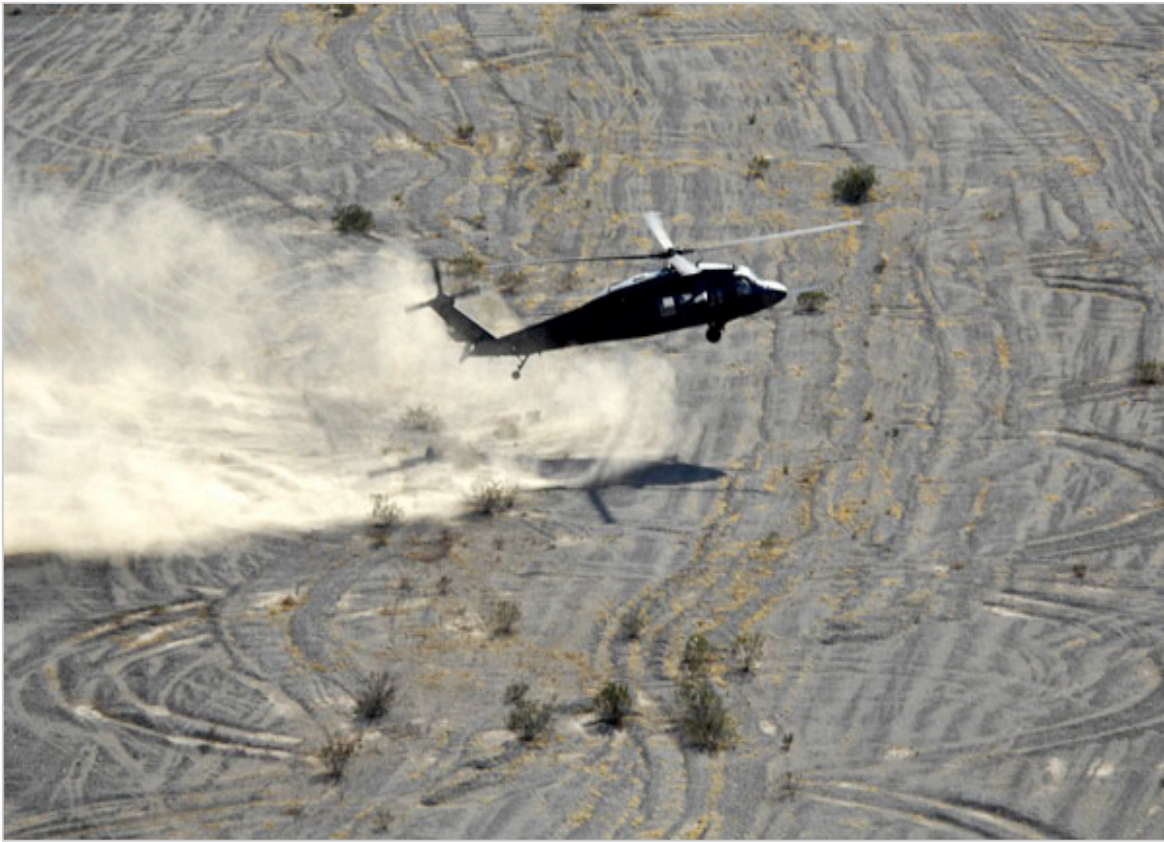
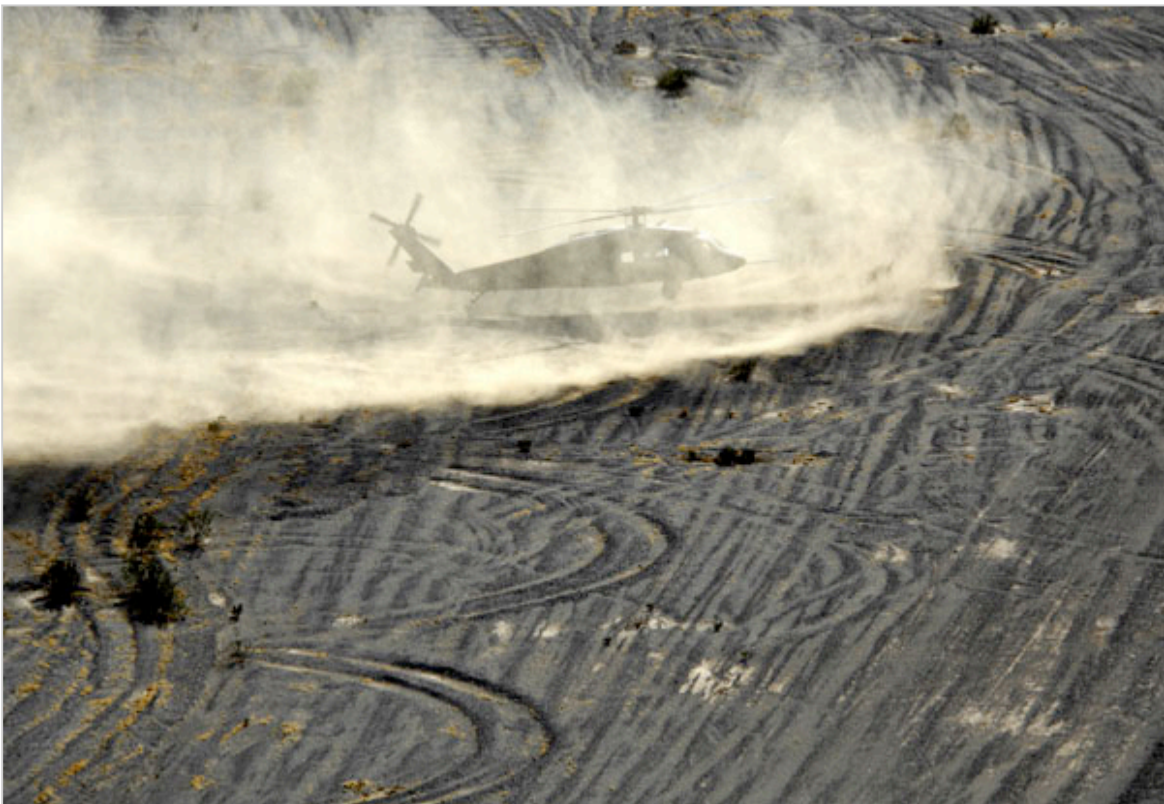
Figure 1. UH-60 Blackhawk performing test landing in brownout at Yuma Proving Grounds.

Rotorcraft brownout is a critical problem experienced by helicopters when landing in dry, sandy ground conditions. (Helicopters landing in powdery snow experience a similar problem referred to as whiteout). Brownout is caused by dust particles that get entrained in the rotor downwash while the helicopter is in ground effect. The dust can reduce or completely obscure the pilot's visibility of the ground and horizon, which are two important orientation cues used for landing (Figure 1). Due to recent military activity in desert environments, brownout

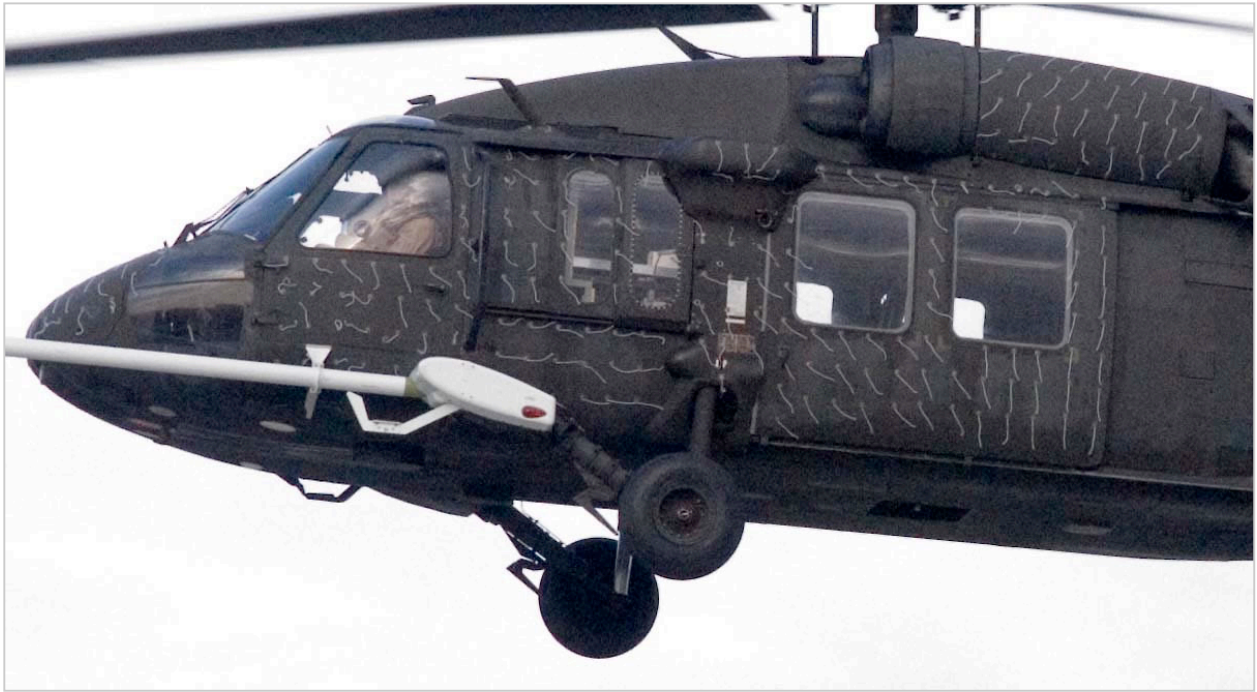
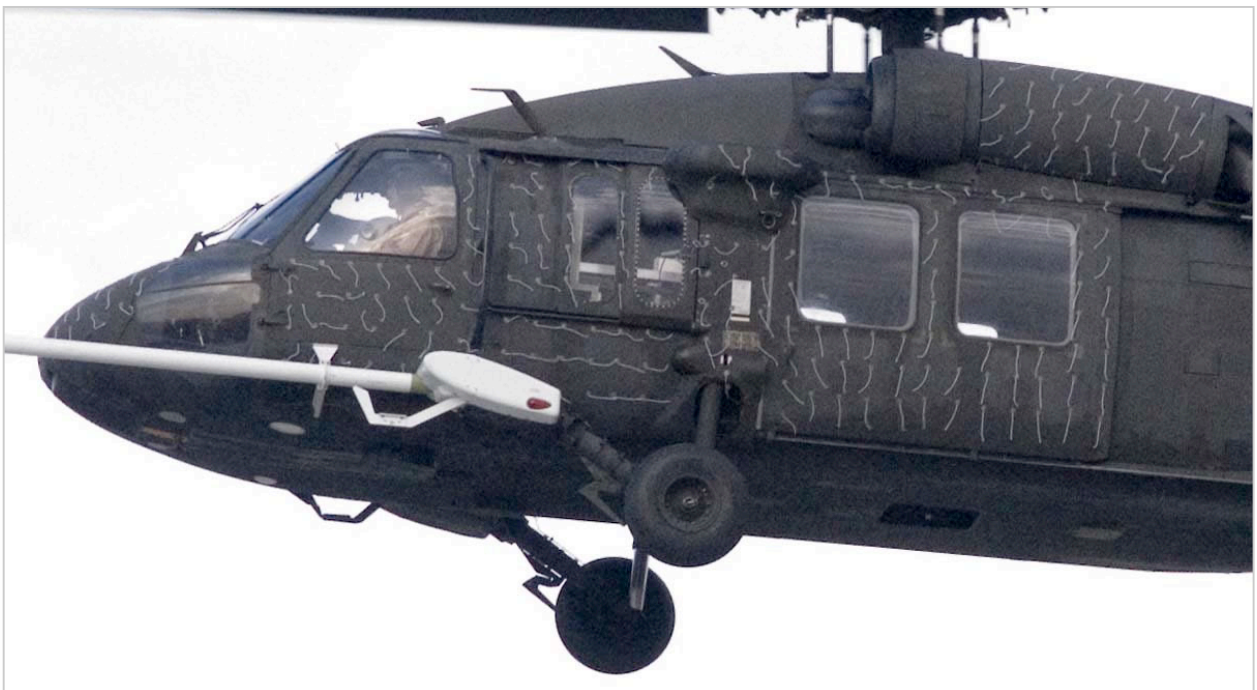
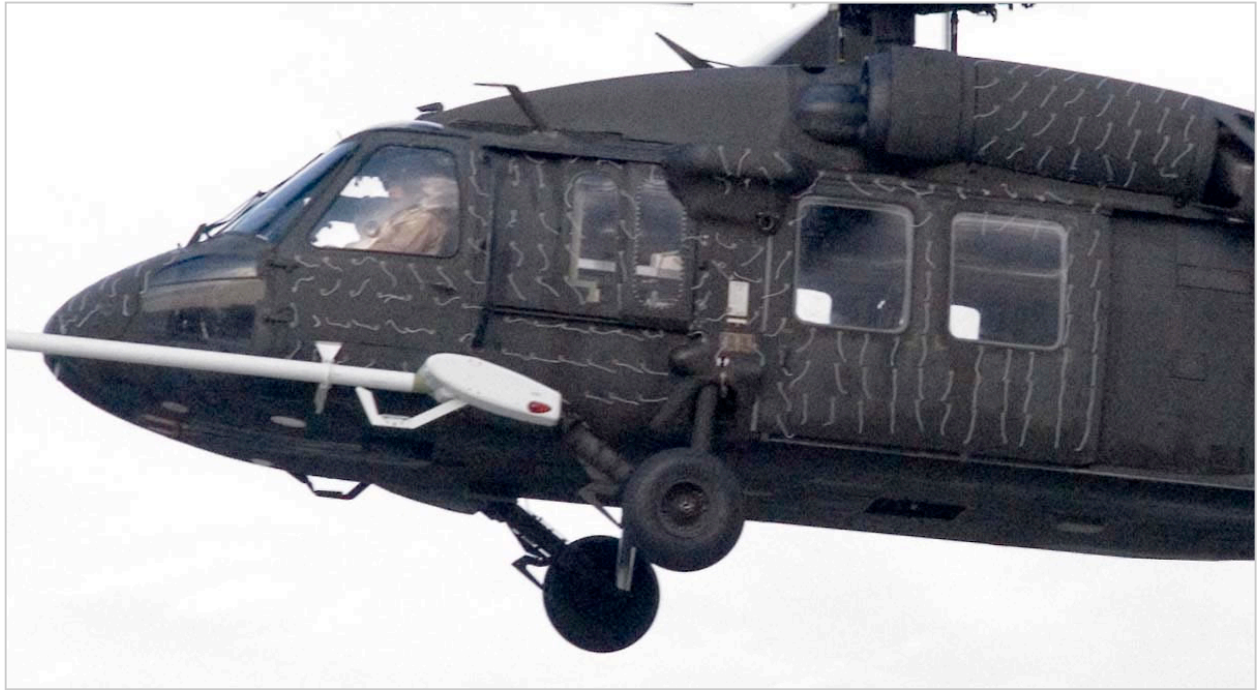
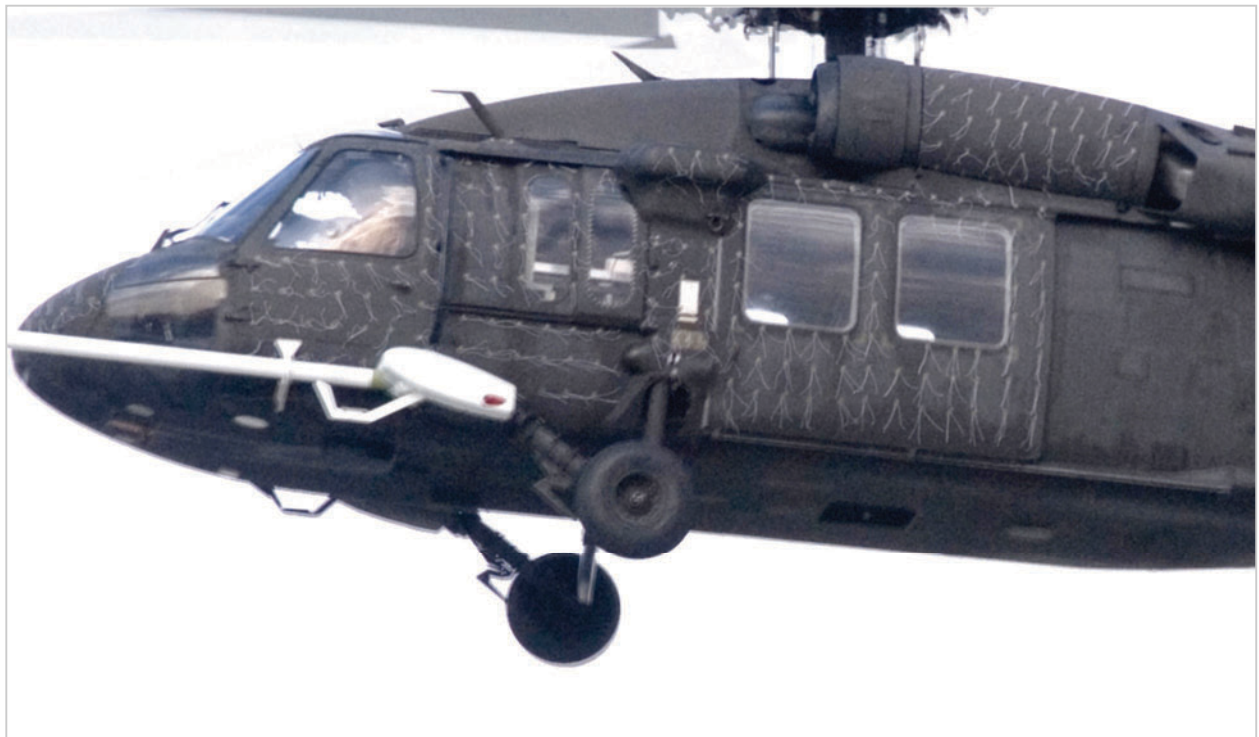
Figure 4(a). Single instantaneous airframe tuft pattern; Wheel height=50 ft.

Figure 4(b). Single instantaneous airframe tuft pattern; Wheel height=50 ft.

Figure 4(c). Single instantaneous airframe tuft pattern; Wheel height=50 ft.

Figure 4(d). Overlay of three instantaneous airframe tuft images; Wheel height=50 ft.

Figure 4. UH-60 airframe tufts in hover at 50-ft wheel height (OGE).

Figures 4(a) through 4(c) show single instantaneous photographs of airframe tufts on the UH-60L hovering out of ground effect (OGE) at 50-ft wheel height. Figure 4(d) represents an overlay of all 3 instantaneous images, providing information on average tuft direction and degree of flow steadiness (from degree of tuft coning) at this wheel height. The flow is clearly not steady. However, in general, tufts are seen to be pointing downwards on the side of the airframe (in the direction of the rotor downwash) indicating attached flow.

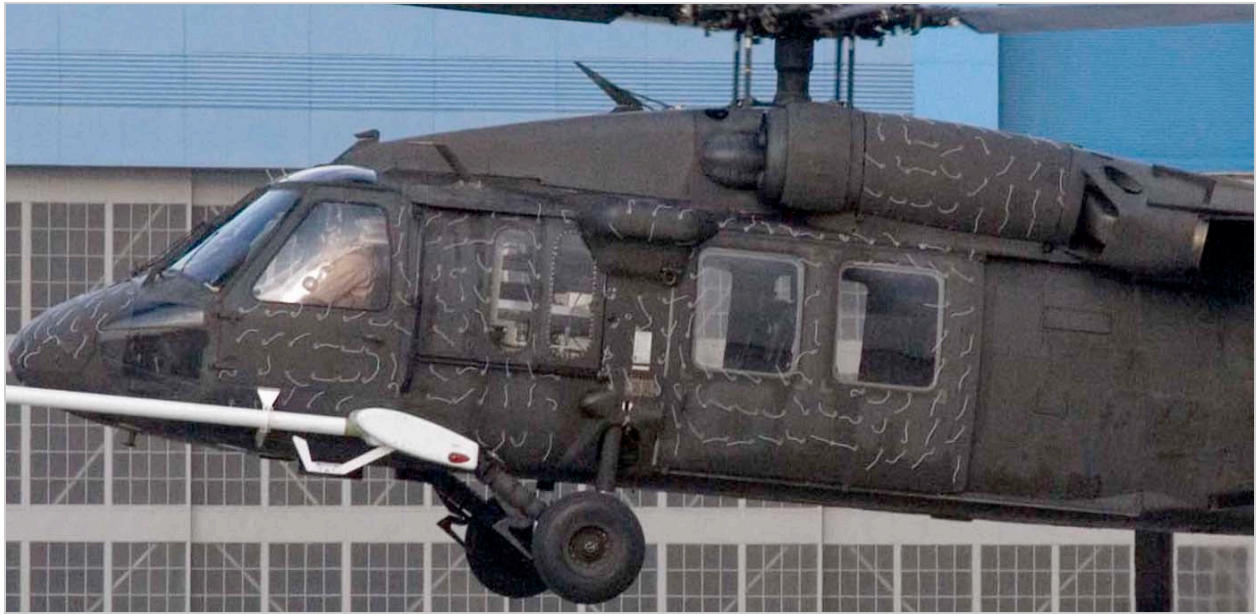
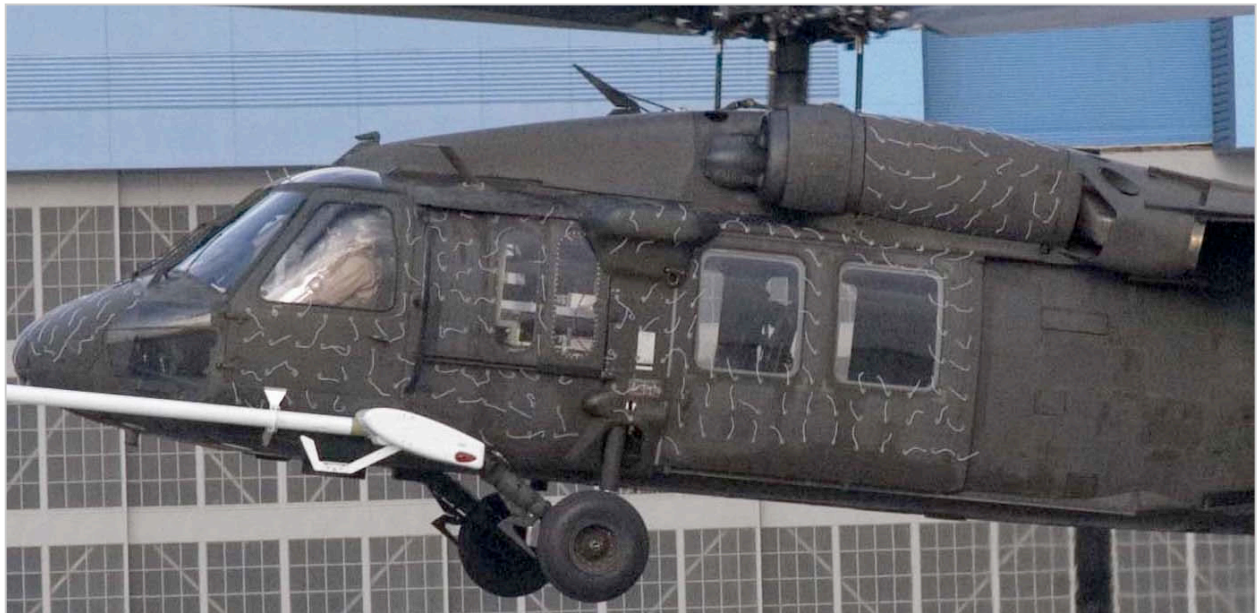
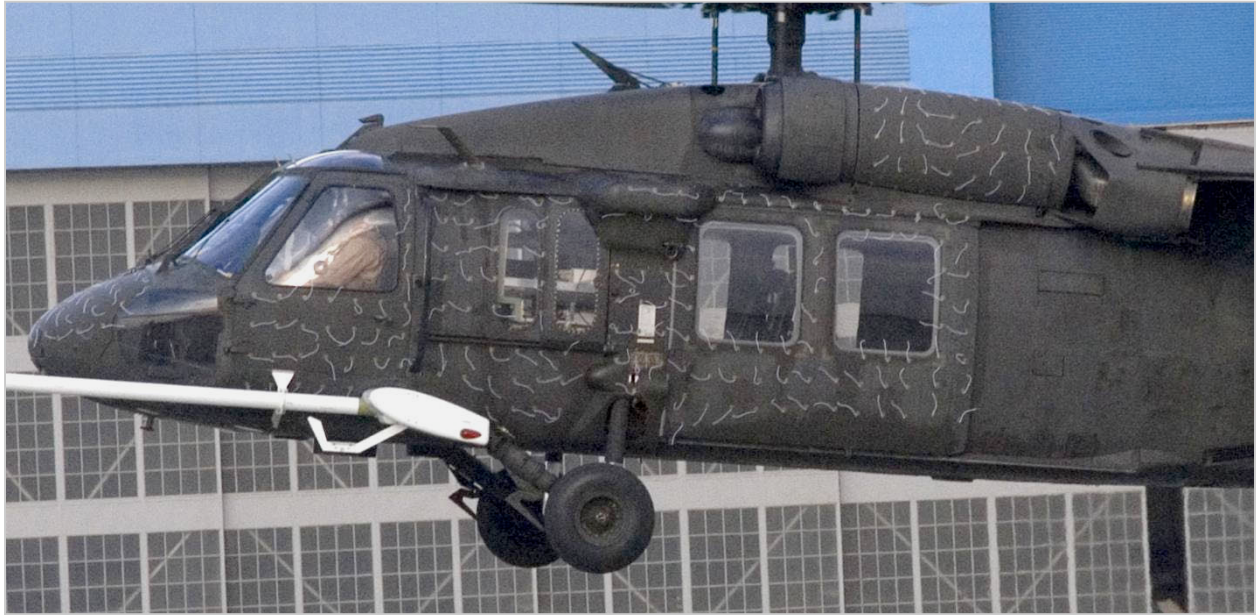
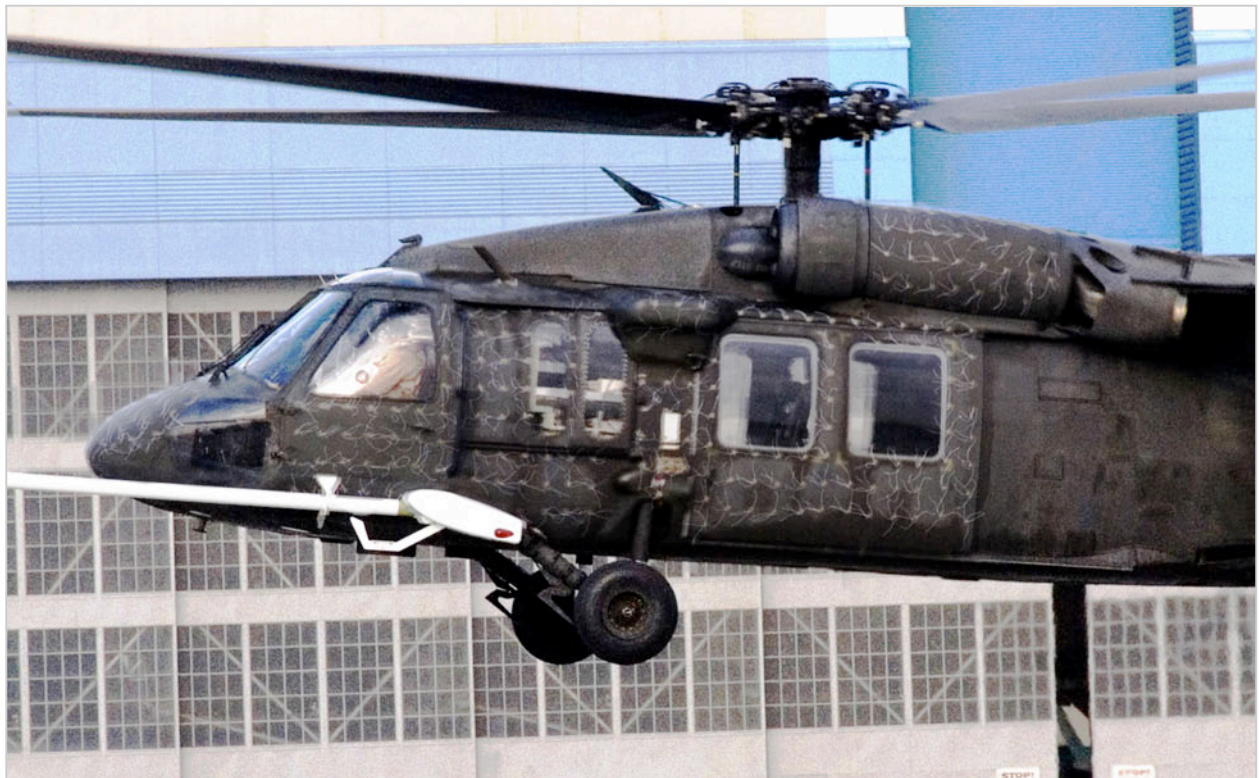
Figure 5(a). Single instantaneous airframe tuft pattern; Wheel height=5 ft.

Figure 5(b). Single instantaneous airframe tuft pattern; Wheel height=5 ft.

Figure 5(c). Single instantaneous airframe tuft pattern; Wheel height=5 ft.

Figure 5(d). Overlay of three instantaneous airframe images; Wheel height=5 ft.

Figure 5. UH-60 airframe tufts in hover at 5-ft wheel height (IGE).

Figures 5(a) through 5(c) show single instantaneous photographs of airframe tufts on the UH-60L hovering in ground effect (IGE) at 5-ft wheel height. Many tufts can be seen pointing upwards toward the rotor and away from the ground. Figure 5(d) represents an overlay of all 3 instantaneous images providing information on average tuft direction and degree of steadiness. In general, for the rotor in ground effect, the airframe tufts are very unsteady (the degree of unsteadiness increasing as the rotor approaches the ground). Many tufts show a large range of motion including complete reversal of flow direction. In general, tufts near the rotor hub tend to be pointing upwards.

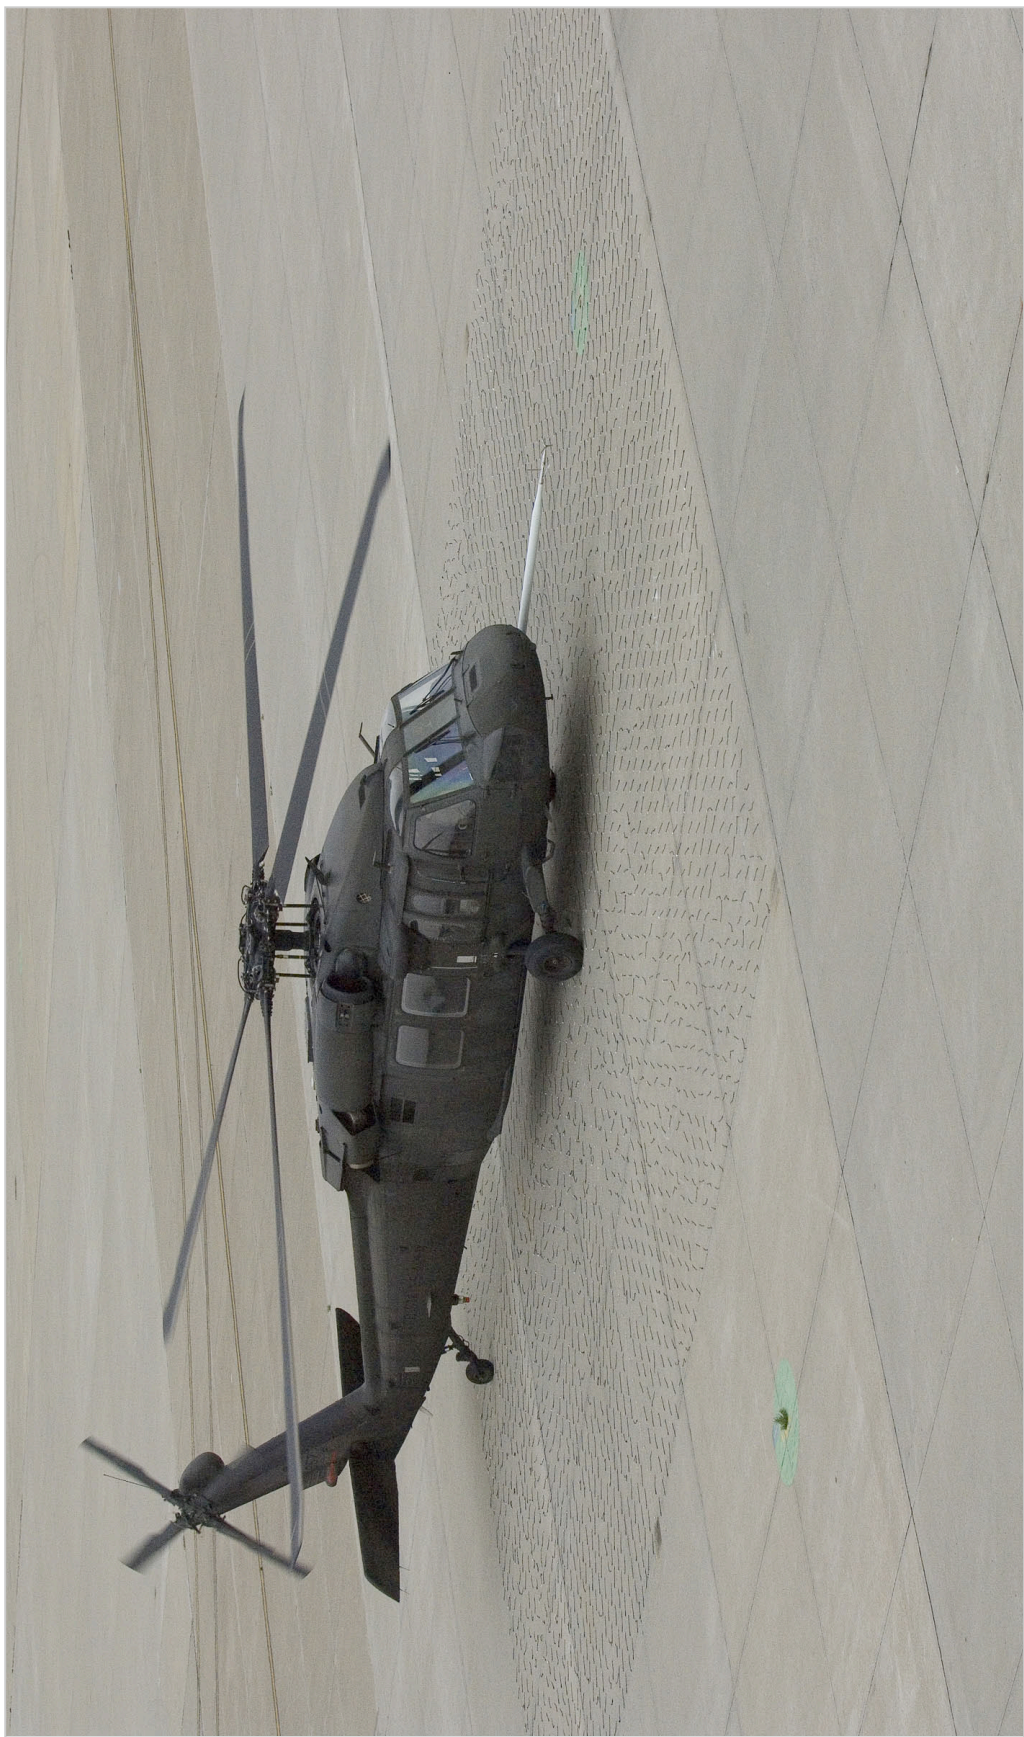
Figure 6. Original UH-60 instantaneous ground plane tuft image; Wheel height=0 ft.

unsteadiness due to pilot induced motions of the rotor. Ground plane tuft images were acquired with the UH-60L with wheels on the ground, rotor spinning at full rpm with collective at 75% of hover value. Figure 6 shows a single instantaneous photograph of the UH-60L with wheels on the ground, the image being taken from the roof of an adjacent building. All photographs of the ground plane tufts were acquired from this vantage point as described earlier. The original oblique view of the ground plane tufts shown in Figure 6 is difficult to interpret. Using Adobe Photoshop™, this image has been reoriented to show the ground plane tufts from a birds-eye view. Figure 7 shows Figure 6 after reorientation. This represents the view an observer would see from immediately above the center of the tuft grid. Because the image has been reoriented, the airframe shown in the upper right hand corner of Figure 7 appears warped. One feature in Figure 7 that should be readily recognized from Figure 6 is the white boom protruding from the front of the aircraft. The rotor disk and an outline of the airframe in plan view have been added for clarity. To remove the 180-degree directional ambiguity associated with any tuft, note that the silicone adhesive used to anchor the tuft to the ground is white. The instantaneous flow pattern under the rotor disk appears relatively disorganized. Figure 8 shows the result of averaging 25 such instantaneous images acquired every 3-seconds over a period of 1 minute and 15 seconds. Significant tuft coning is an indication of flow unsteadiness in Figure 8. Minimal tuft coning is an indication of steady flow. No tuft coning is an indication that the tuft has become entangled with an adjacent tuft or has become stuck to the ground.
